# YOUR INSPECTION REPORT

456 Castle Avenue , Fargo, ND

April 20, 2012

**PREPARED BY:** Craig A. Manock representing Northern States Inspection

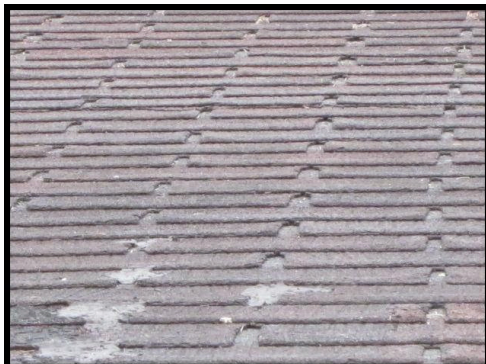
##### *5.1 Composition Shingles:*

There are shingles that are clawing/curling/not laying flat (3C.02). There are shingles that are eroded/pitting/have granules missing (3C.03). Evidence of repairs may indicate past/current leakage (3C.12). Roof appears to be at/near the end of its useful life. Anticipate the need to replace the roof covering in the not too distant future.

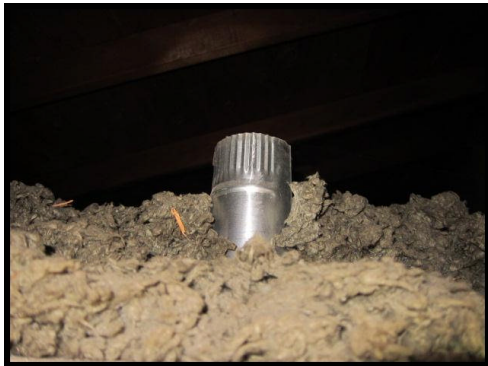
### 5.5 Attic:

Bathroom vent should not discharge into the attic ([8C.16](#), [9D](#) & [3C.12](#)).

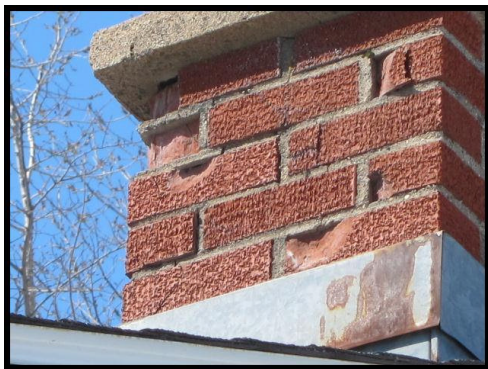
### 5.6

Chimney shows evidence of spalling - surface deterioration of the bricks. This condition should be monitored because if spalling continues, rebuilding the chimney will ultimately be necessary ([1B.02](#)).

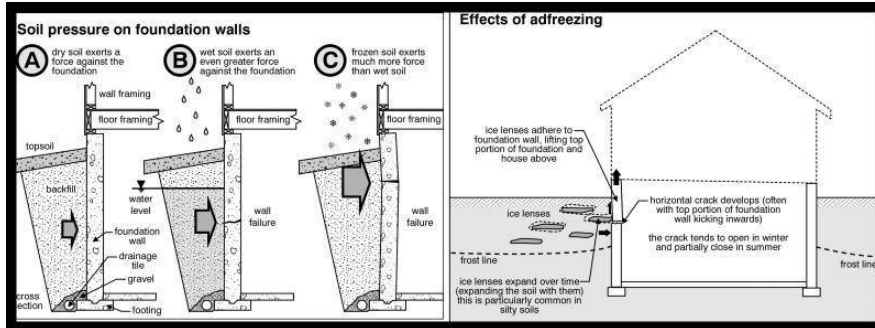
#### 8.1

Horizontal cracking was observed in the foundation. Cracks of this nature are usually the result of soil pressures on the exterior of the foundation wall, or Adfreezing, frozen soil attaching itself to the foundation wall and causing uplift. In either case, attempts should be made to reduce moisture content in the soil adjacent to the foundation . Horizontal cracking should be further evaluated by a qualified foundation contractor ([1C.21](#) & [1C.22](#)).

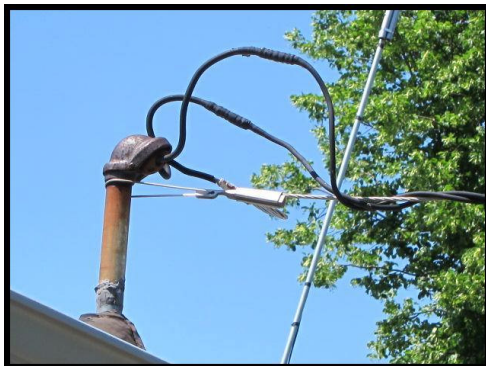
#### 9.1

The overhead service entrance weather head is not properly oriented and/or there is not a sufficient drip loop ([5C.74](#)).

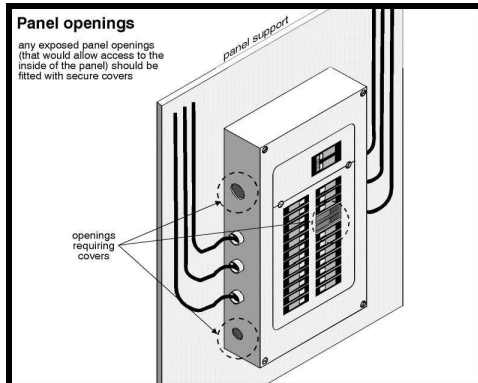
9.3

Any openings in the main panel should be covered ([5C.06](#)).

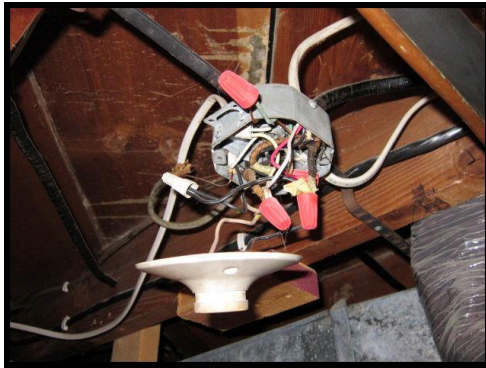
9.7

Hanging light fixture in basement needs to be secured. NOTE: The current electrical box may be exceeding the cable fill requirements. Please have an electrician verify this during the repair.

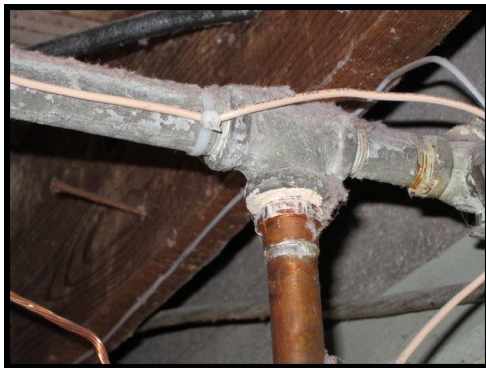
10.1

Copper/Galvanized piping contact is noted. Correction is recommended ([4C.06](#)).

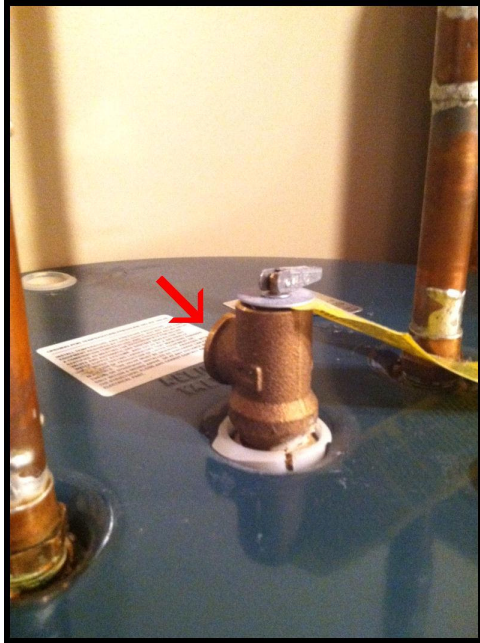
10.4

Pressure relief valve drain pipe is missing. This drain pipe is intended to safely vent excess pressure in the event water heater becomes over pressurized or overheated. This is a safety concern. It is important to have this drain line extended to within 6 inches of the floor, in order to protect persons from the sudden escape of steam which may occur if this valve is ever called into play.

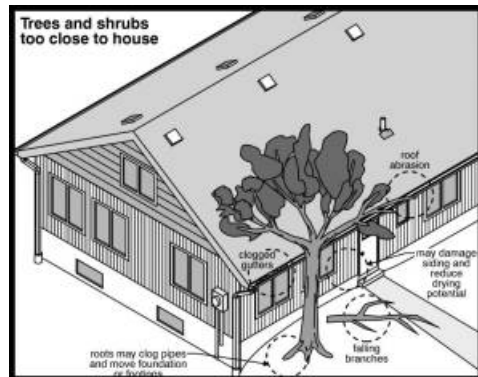
3.1

The proximity of a tree at the rear of the house on the NE corner could disrupt drainage pipes, cause mechanical damage to the exterior of the house, or influence the foundation over time. It would be wise to consider the removal of the tree.

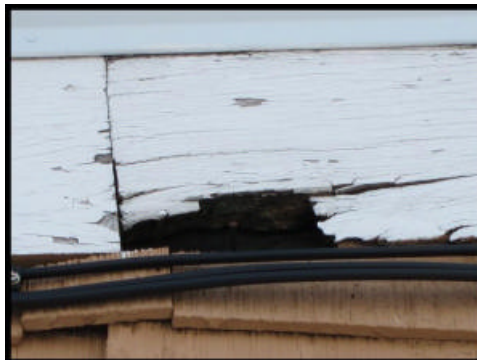
#### 4.1 Wood Siding:

Moisture has penetrated the siding in areas causing rot. All rotted siding should be replaced or repaired with a patching material designed for wood repair ([1C.06](#)).

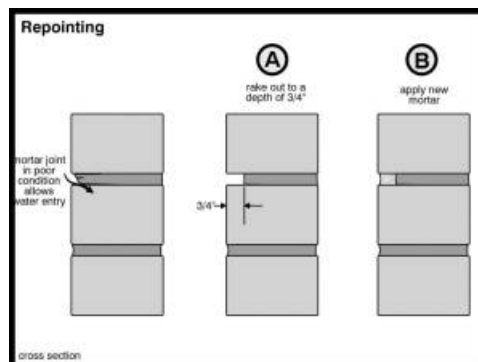
#### 4.2 Veneer:

The masonry mortar joints at the front of the house show signs of deterioration and should be repointed ([1B.07](#)).

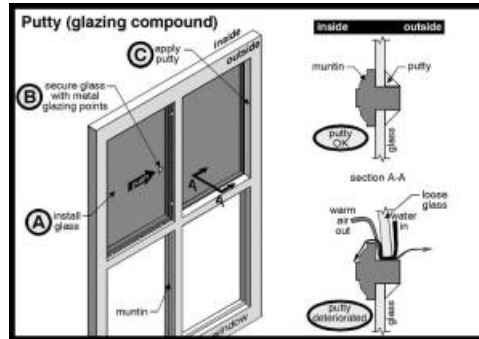
4.3

The glazing compound was cracked and deteriorated with some pieces of glazing compound missing. Replacing the bad glazing compound is recommended ([2C.01](#)).

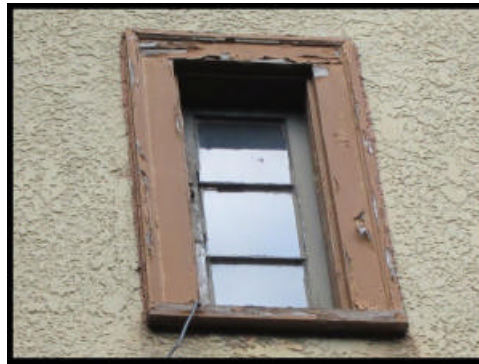
4.4

The peeling window frame(s) and trim should be scraped and painted ([2P](#)).

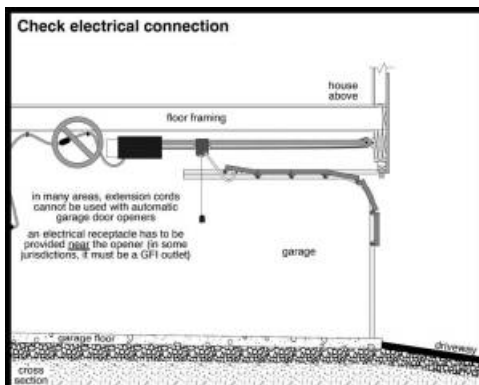
### 4.7 Distribution Wiring:

The door opener was wired with an extension cord. While a permanent outlet may not have been required when the home was built, ideally garage door openers should be powered by a dedicated outlet ([5C.63](#)).

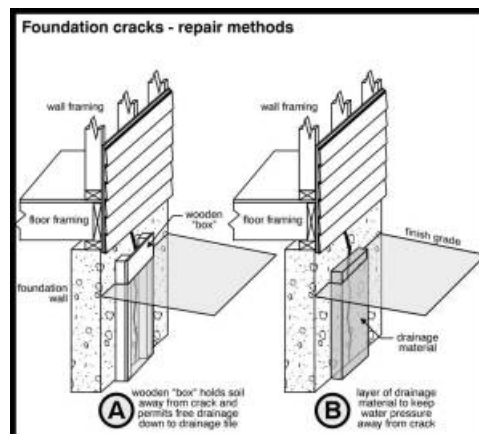
4.10

Foundation cracking was observed on the center of the East foundation wall. All cracks in the exterior foundation should be kept sealed to prevent moisture/insect entry. See Foundation & Structural Framing section of this report for more information about the foundation.

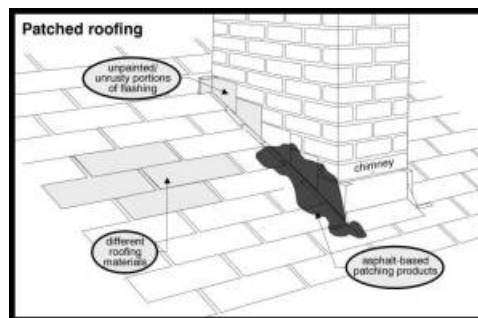
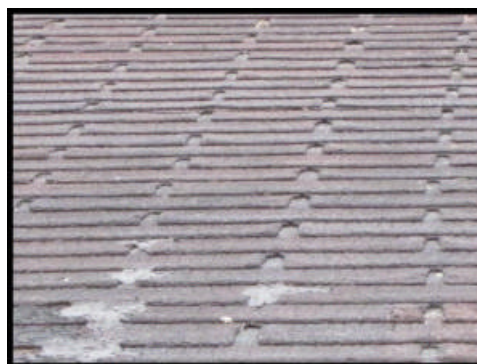
#### 5.1 Composition Shingles:

There are shingles that are clawing/curling/not laying flat (3C.02). There are shingles that are eroded/pitting/have granules missing (3C.03). Evidence of repairs may indicate past/current leakage (3C.12). Roof appears to be at/near the end of its useful life. Anticipate the need to replace the roof covering in the not too distant future.

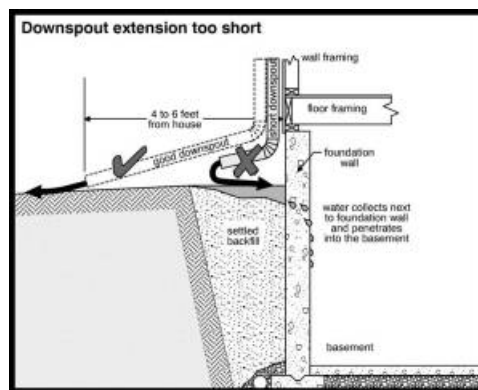
5.3

The downspouts should extend further from the house. Storm water should be encouraged to flow away from the building at the point of discharge ([3C.06](#)).

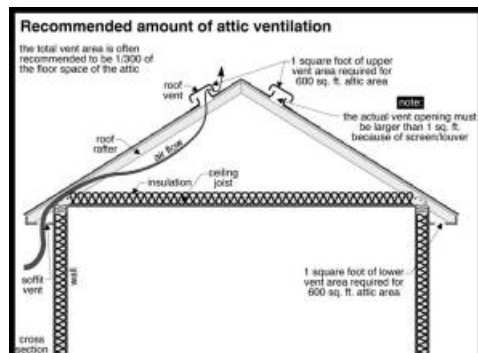
5.4

The level of ventilation could be improved. Proper ventilation will help to keep the house cooler during warm weather and extend the life of the roofing materials. In cold weather, it will help reduce the potential for ice dams on the roof and condensation within the attic ([3C.17](#)).

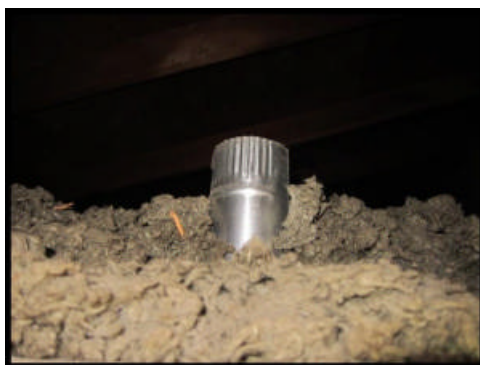
5.5 Attic:

Bathroom vent should not discharge into the attic (8C.16, 9D & 3C.12).

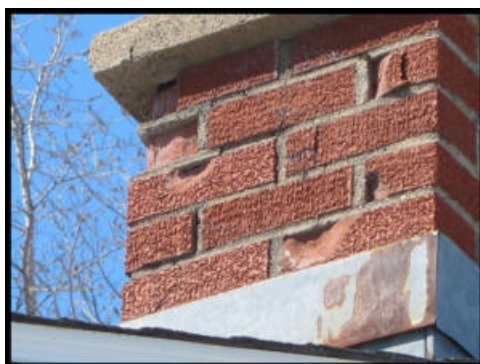
5.6

Chimney shows evidence of spalling - surface deterioration of the bricks. This condition should be monitored because if spalling continues, rebuilding the chimney will ultimately be necessary (1B.02).

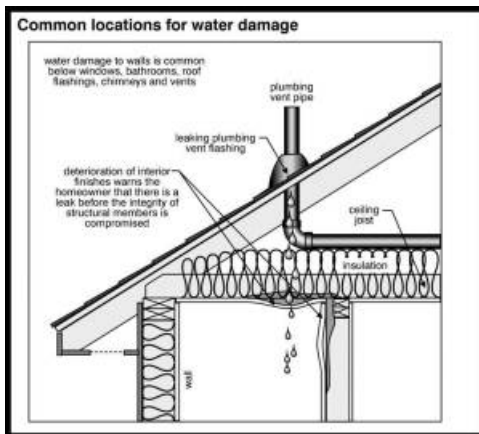
6.1

Moisture damage was observed below the window in the upstairs SE bedroom.

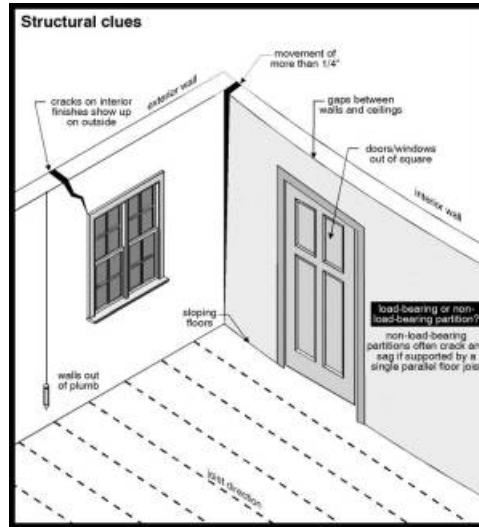
6.2

Larger than typical cracks were observed (7C.01).

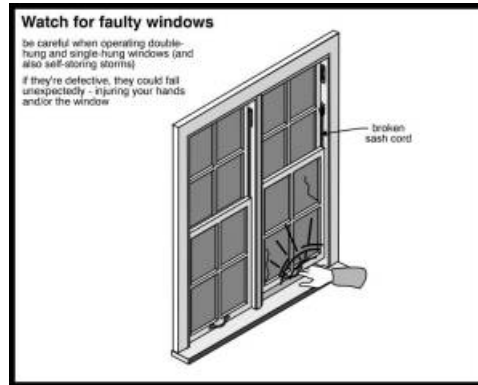
6.5

Damaged/broken sash cords, ropes, or balances viewed (7C.14).

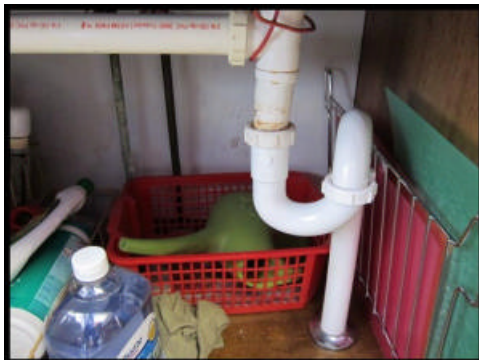
#### 7.1 Sinks (8C.06):

An S Trap has been used. Ideally, S traps should be replaced as they are subject to siphoning problems. S traps are common in older homes. Replacement is sometimes difficult and thus the S traps are usually tolerated. Care should be taken to keep the trap primed. Fixtures should be monitored for sewer odor (4A.08).

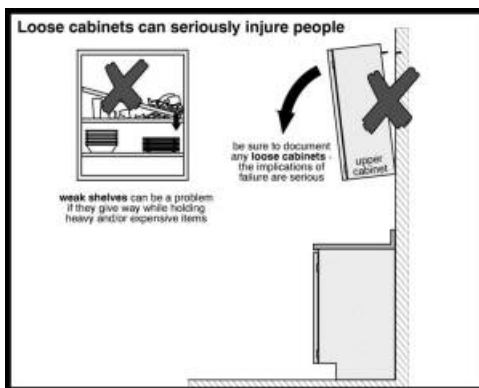
#### 7.2 Counters & Cabinets:

Cabinets are not firmly attached to wall.

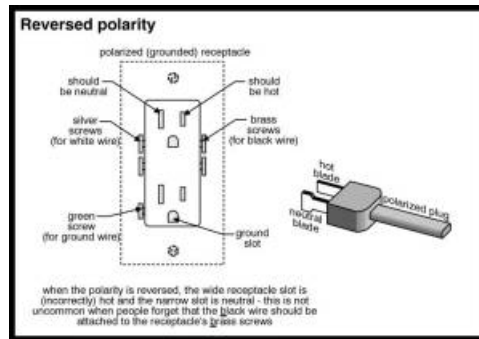
### 7.3 Electrical:

An outlet has reversed polarity, wired backwards, ALL outlets and their circuits should be investigated and improved as necessary (5C.65).

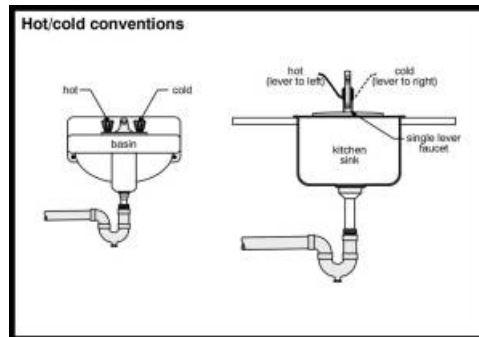
### 7.5 Sinks:

Faucet had reversed hot and cold flow: Faucets with incorrect positioning of hot and cold water control often have their control cartridge or plastic insert for attachment of the handle installed upside down.

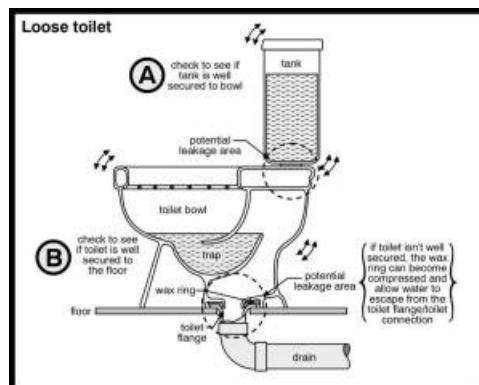
### 7.6 Toilets:

Toilet is loose at floor (4C.04). NOTE: Loose toilets are prone to leakage. Past moisture damage to the surrounding floor, that was not detected during the inspection unless otherwise noted, may be present. Loose toilets should be removed, the wax ring replaced and then resecured. Any moisture damage to the floor should also be corrected.

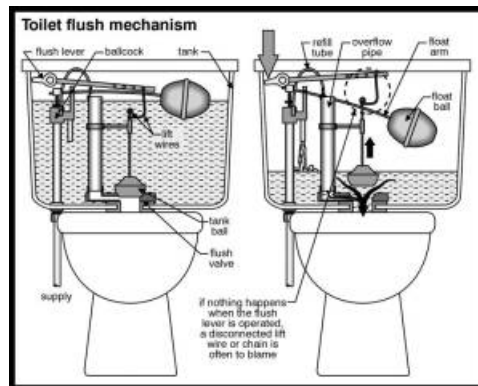
7.10 Toilets:

Fill valve is worn and needs replacement (4C.04).

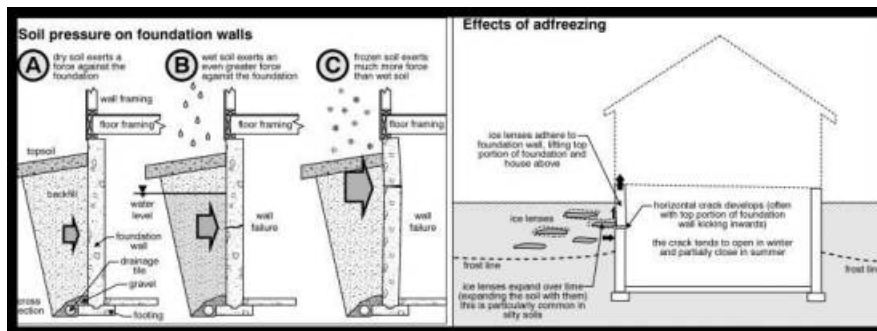
8.1

Horizontal cracking was observed in the foundation. Cracks of this nature are usually the result of soil pressures on the exterior of the foundation wall, or Adfreezing, frozen soil attaching itself to the foundation wall and causing uplift. In either case, attempts should be made to reduce moisture content in the soil adjacent to the foundation. Horizontal cracking should be further evaluated by a qualified foundation contractor ([1C.21](#) & [1C.22](#)).

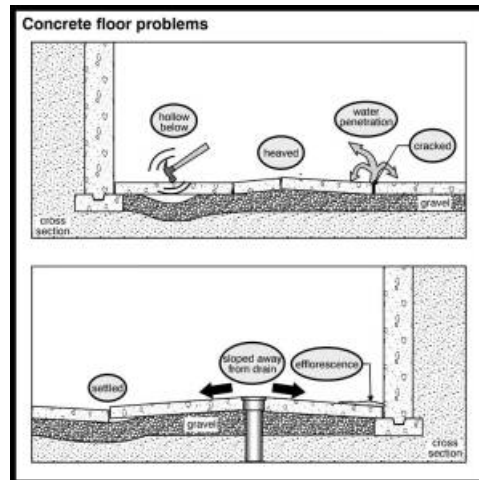
8.2

There are cracks in the concrete basement floor (1C.24).

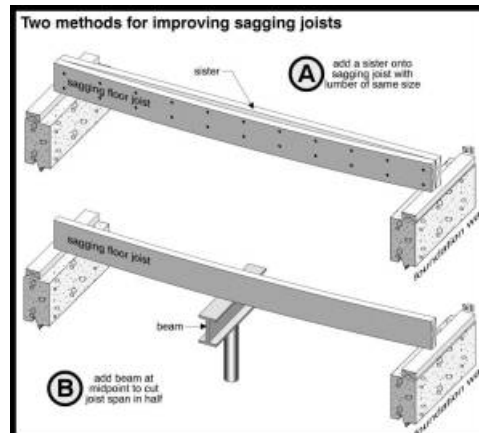
8.3 Floor Joists:

The floor structure has experienced some sagging and movement (1C.12).

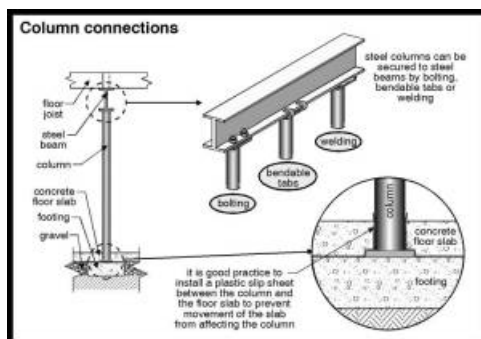
#### 8.4 Columns/Supports:

A column is not properly secured (1C.47).

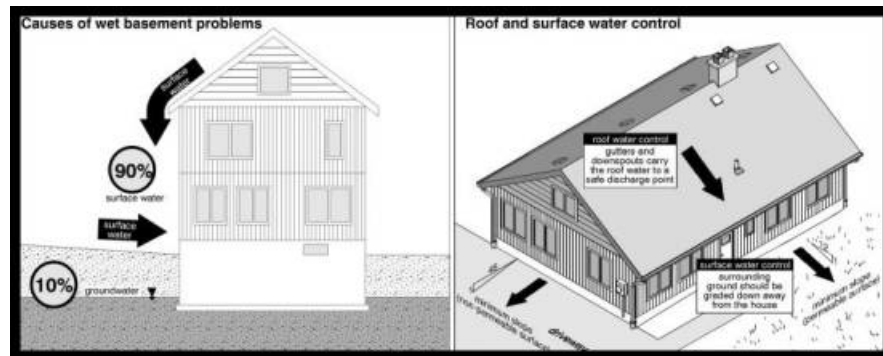
#### 8.9 Severity of Leakage:

The basement shows evidence of moisture penetration in the form of one or a combination of efflorescence, peeling paint, stains, wet areas, mold, interior finish damage, or prior attempts to repair/seal the basement. It should be understood that it is impossible to predict the severity or frequency of moisture penetration on a one-time visit to a home. Virtually all basements exhibit signs of moisture penetration and virtually all basements will indeed leak at some point in time. The visible evidence is not considered unusual for a home of this age, construction, and location. Further monitoring of the foundations will be required to determine what improvements, if any, will be required. Basement leakage rarely affects the structural integrity of a home. The vast majority of basement leakage problems are the result of insufficient control of storm water at the surface. The ground around the house should be sloped to encourage water to flow away from the foundations. Gutters and downspouts should act to collect roof water and drain the water at least five (5) feet from the foundation, or into a functional storm sewer. Downspouts that are clogged or broken below grade level, or that discharge too close to the foundation are the most common source of basement leakage. In the event that basement leakage problems are experienced, lot and roof drainage improvements should be undertaken as a first step. Please beware of contractors who recommend expensive solutions. Excavation, damp proofing and/or the installation of drainage tiles should be considered a last resort. In some cases, however, it is necessary. Your plans for using the basement may also influence the approach taken to curing any dampness that is experienced.

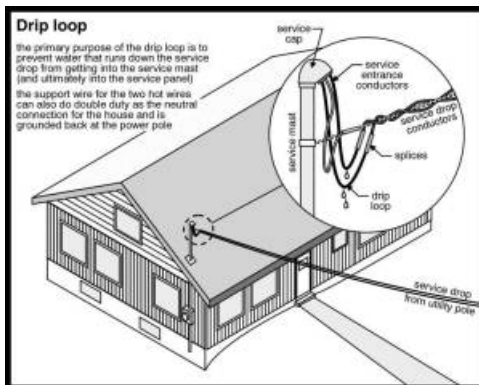
9.1

The overhead service entrance weather head is not properly oriented and/or there is not a sufficient drip loop (5C.74).

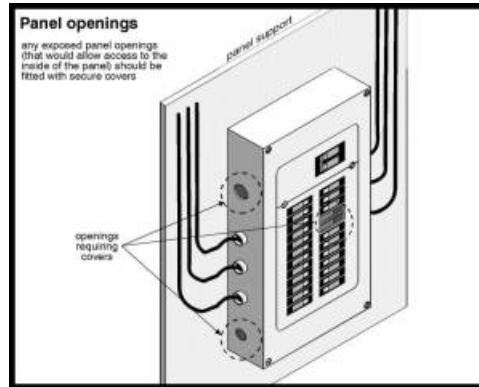
9.3

Any openings in the main panel should be covered (5C.06).

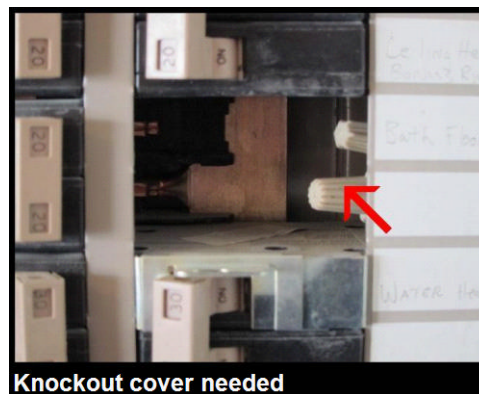
9.4

Knockout cover needed

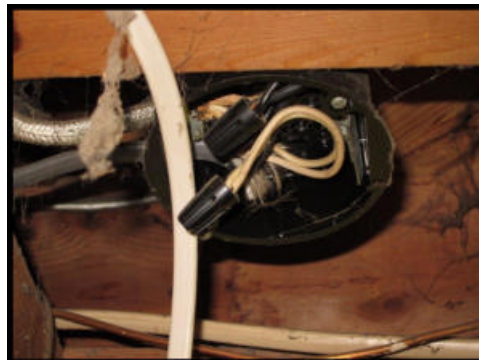
9.5

All junction boxes should be fitted with cover plates, in order to protect the wire connections (5C.06).

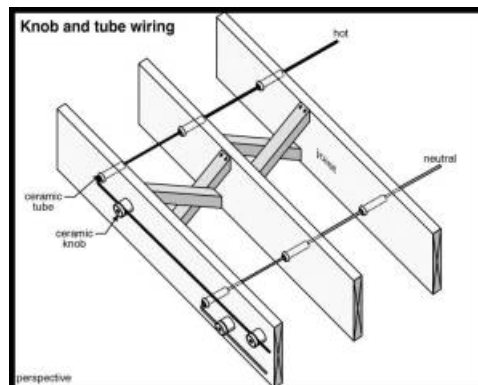
9.6

There is knob & tube wiring present in the home. It should be pointed out that, although this wiring is old, it is typically not necessary to replace all of the wiring, however updating the wiring is highly recommended. Whenever knob & tube wiring is present in a home we strongly encourage you to hire a qualified licensed electrician to inspect the complete electrical system and make any recommendations and/or repairs (5A.10).

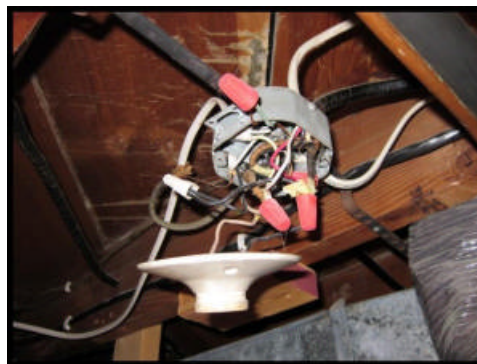
9.7

Hanging light fixture in basement needs to be secured. NOTE: The current electrical box may be exceeding the cable fill requirements. Please have an electrician verify this during the repair.

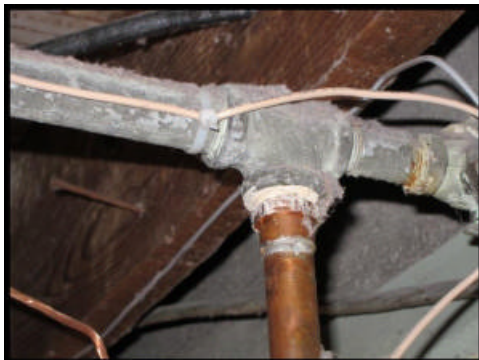
10.1

Copper/Galvanized piping contact is noted. Correction is recommended (4C.06).

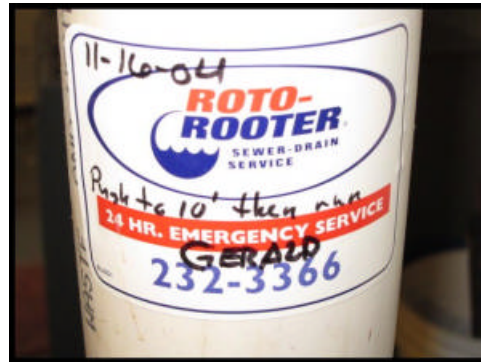
10.3

A Roto-Rooter sticker was present. This normally indicates drainage problems, caused by tree roots? crushed piping? etc. You should inquire with seller about this situation.

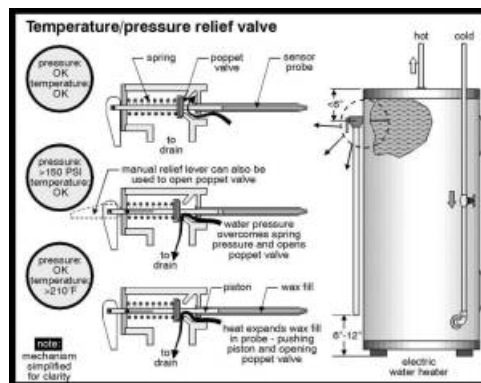
10.4

Pressure relief valve drain pipe is missing. This drain pipe is intended to safely vent excess pressure in the event water heater becomes over pressurized or overheated. This is a safety concern. It is important to have this drain line extended to within 6 inches of the floor, in order to protect persons from the sudden escape of steam which may occur if this valve is ever called into play.

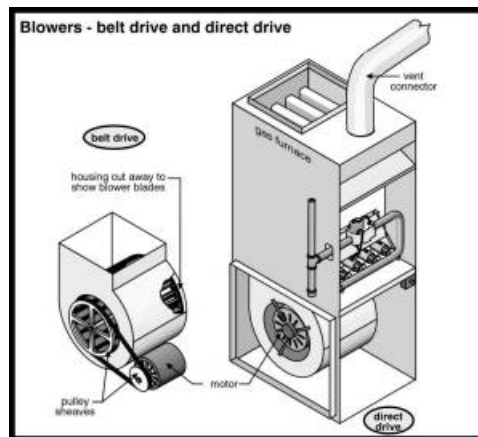
11.3 Blower Fan:

Unusual sounds and/or vibration was noted (6C.03).

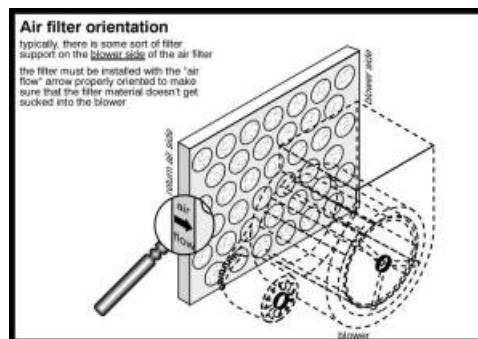
11.5 Air Filter:

Suggest cleaning/changing filter (6C.01).
