# YOUR INSPECTION REPORT

456 Castle Avenue , Fargo, ND

April 20, 2012

**PREPARED BY:** Craig A. Manock representing Northern States Inspection

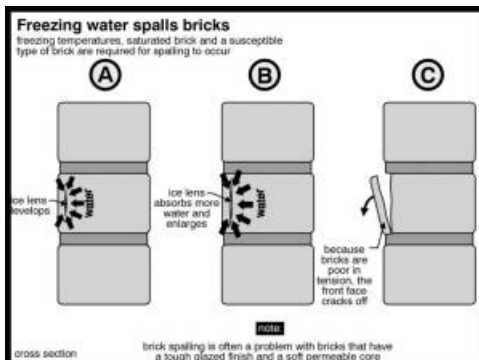
5.7

Chimney shows evidence of spalling - surface deterioration of the bricks. This condition should be monitored because if spalling continues, rebuilding the chimney will ultimately be necessary (1B.02).

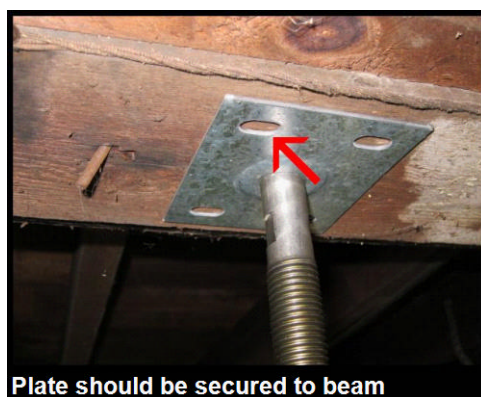
A column is not properly secured (1C.47).

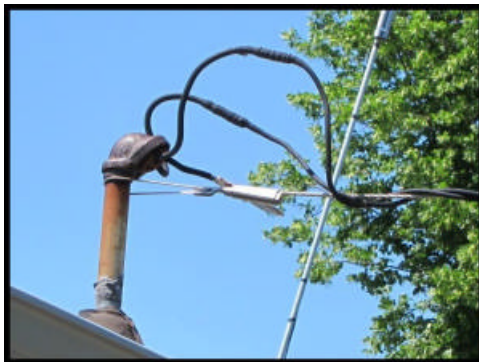
9.2

The overhead service entrance weather head is not properly oriented and/or there is not a sufficient drip loop (5C.74).

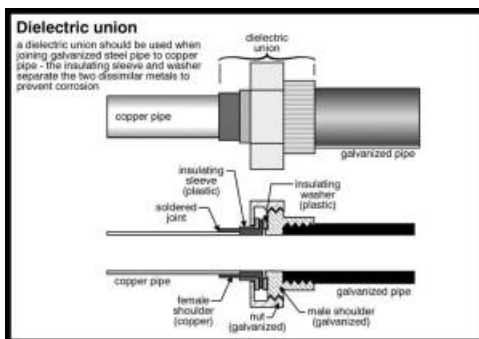
10.2

Copper/Galvanized piping contact is noted. Correction is recommended (4C.06).

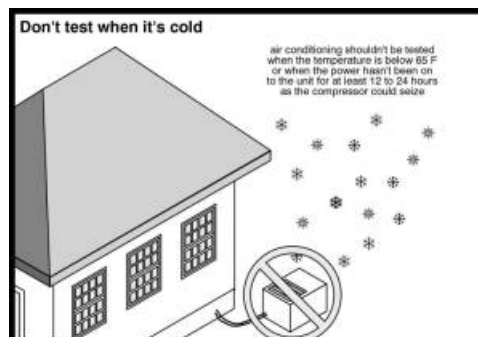
11.6 System Condition:

Outside temperature did not allow testing of equipment. To safely operate an air conditioner the overnight temperatures should be 65 degrees or higher. UNIT WAS NOT INSPECTED.
